Airfield Pavement Evaluation, Butts Army Airfield, Fort Carson, Colorado

by Jeb S. Tingle

Final report

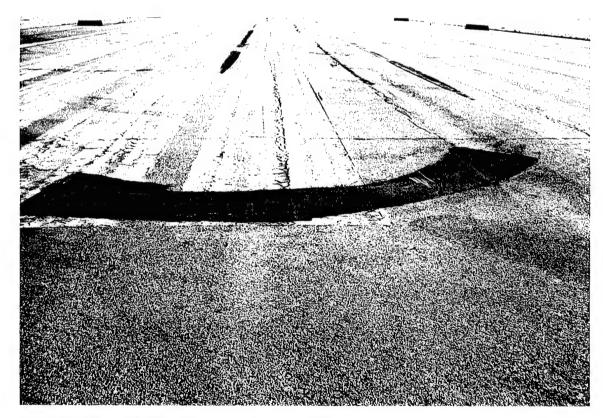
Photo C2. Patch of slippage crack on Runway 13-31

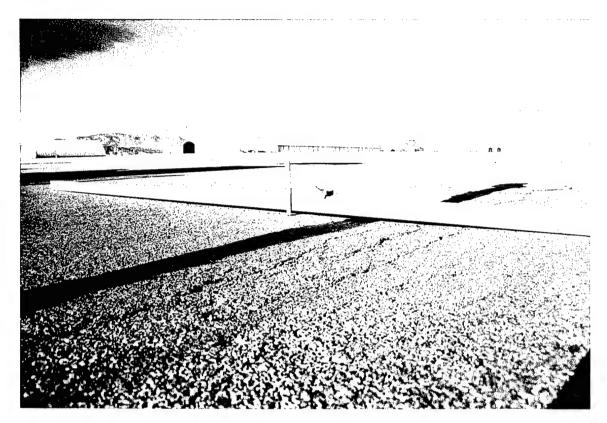
Photo C3. Medium-severity rutting and alligator cracking on Runway 13-31

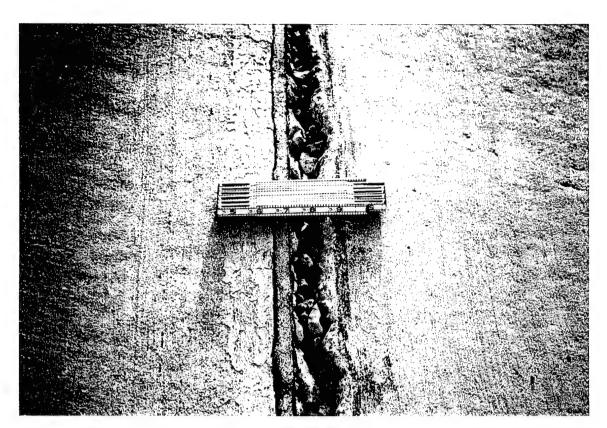
Photo C5. High-severity joint sealant on the Midfield Taxiway

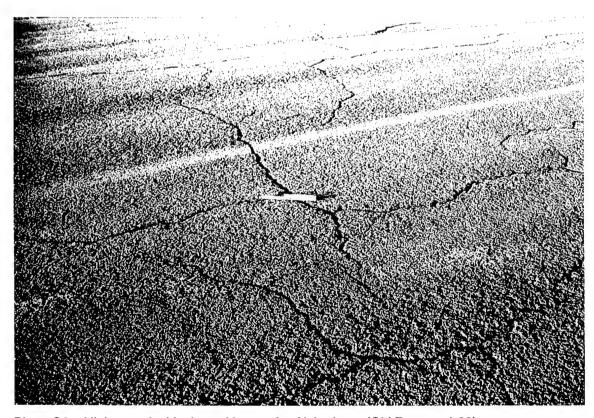
The general condition rating of the Alpha Lane is failed.

Photo C6. High-severity block cracking on the Alpha Lane (Old Runway 4-22)

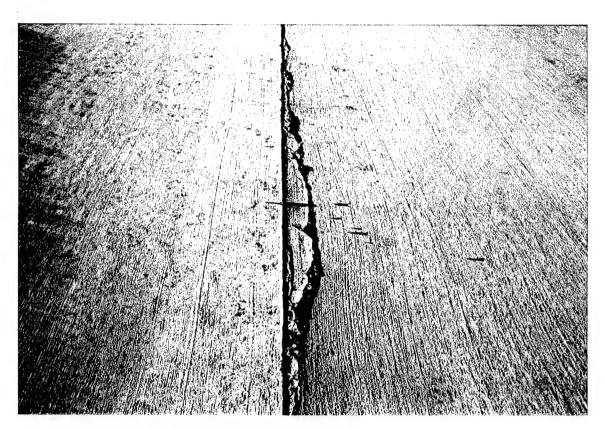
Photo C9. High-severity joint spall on the Parking Apron

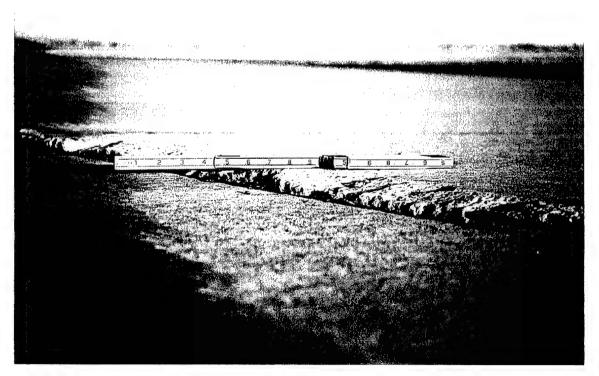
Photo C10. High-severity faulting on the Parking Apron
